TWO CASE-STUDIES OF ROOF FALL ACCIDENTS IN COAL ROADWAY: OCCURRENCE MECHANICAL ANALYSIS IN PREVENTIVE MEASURES

Gui-chen LI, Nong ZHANG, Jia-guang KAN

China University of Mining and Technology, State key laboratory of coal resources and mine safety, Xuzhou, Jiangsu, CHINA

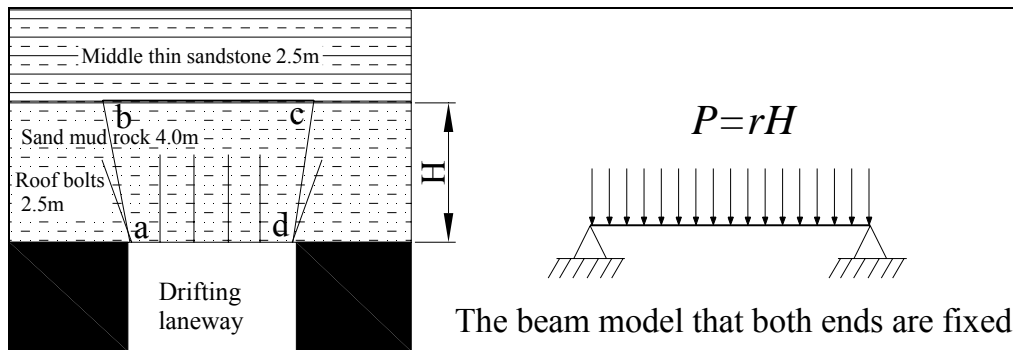
Figure 1.: The mechanics figure of the beam model that both ends are fixed of the first accident.

According to the support of the first accident, if the conditions were stable, the structure of the support manner could be abstracted as the beam model that both ends were fixed^[2], as shown in figure 1. The thickness and intensity of the middle thin sandstone above the immediate roof were too high, so it could be seen as the key stratum^[3], and the bolts-hold stratum of the bolts support formed as the beam model. If the pre-stress was very high^[4], the support ability of the beam structure is F (which is the whole shear ability of the beam structure, MPa), and it could support the wall rock load of the immediate roof P ;

If the conditions of the roof were no variety, the whole bolts-hold region could support the wall rock stress of immediate roof (the locale did do this), it meant that F was bigger than P , so the roof would not have separation layer and fall, the above wall rock could be supported effectively. Nevertheless, as the thickness of the immediate roof of the locale became higher, i.e. H was bigger than before, the wall rock stress P also became bigger than before, but the bolts-hold region did not have change, and its ability F was not alter either, result in P was bigger than F , moreover no effective support structure to share the redundant stress ($P-F$), consequently the ABCD region in figure 1 total fell, the bad accident happened.

- (1) The first accident could be refrained successfully if only the workers of that roadway had a clear cognition and determinant to the changed instance of lithology of the roof, and immediately installed some long cables or anchors as the supplied measure in the appropriate position of the roof.
- (2) If the design of the second accident had been more perfected and improved, and the intension of goaf side and the whole supports structure were strengthened or the supports were more contraposed, the tragedy would never happen.

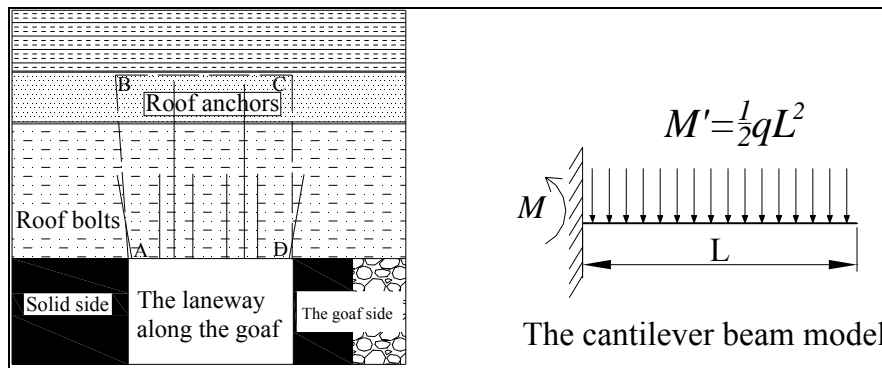
Figure 2.: The mechanics figure of the cantilever beam model of the second accident.

The mechanics model of the second accident could be abstracted as the cantilever beam model [2], which the entity side be treated as the beam’s fixed end, and as the goaf side basically in the no support state, so the support structure formed by roof bolts and anchors as the beam liberty end, therefore, the roof shaped the cantilever beam model, as shown in figure 2. It is very difficult to absolutely fix the cantilever beam, that is to say, the beam and the fixed end both have very high toughness, in fact, it is unpractical, even though the toughness is too high, if the moment of loading is a bit higher, the beam would have some movement, and the whole beam will unstable, at last the beam can curve and destroy easily. The moment of the fixed end of beam is M (the highest moment of the cantilever to resist the curve and destroy, $\text{kN}\cdot\text{m}$), the moment of roof action on the fixed end is M' ,

If the cantilever beam could keep stable, the moment M must be bigger than M' , or else, the cantilever beam would bend and then destroy. After had drifted about 100 meters, outside of the anchors-hold region of the locale roof appeared whole separation layer, however, the goaf side did not have the support ability, so all the load had to be supported by the fixed end of the cantilever beam, when M' was bigger than M , the cantilever beam totally destroyed, so the ABCD region in figure 2 fell wholly, the evil roof fall accident of large area happened in the end.
