LANDSLIDES IN BELO HORIZONTE, BRAZIL

This paper presents the results of two successive rainy-season monitoring carried out in the “Taquaril” slope, located at the “Taquaril” neighborhood. Also, it includes the following slope’s studies: stability analysis, geological and geo-morphological characterization. Here, the main goal was to explain why this slope has failed and to identify the main trigger mechanisms.

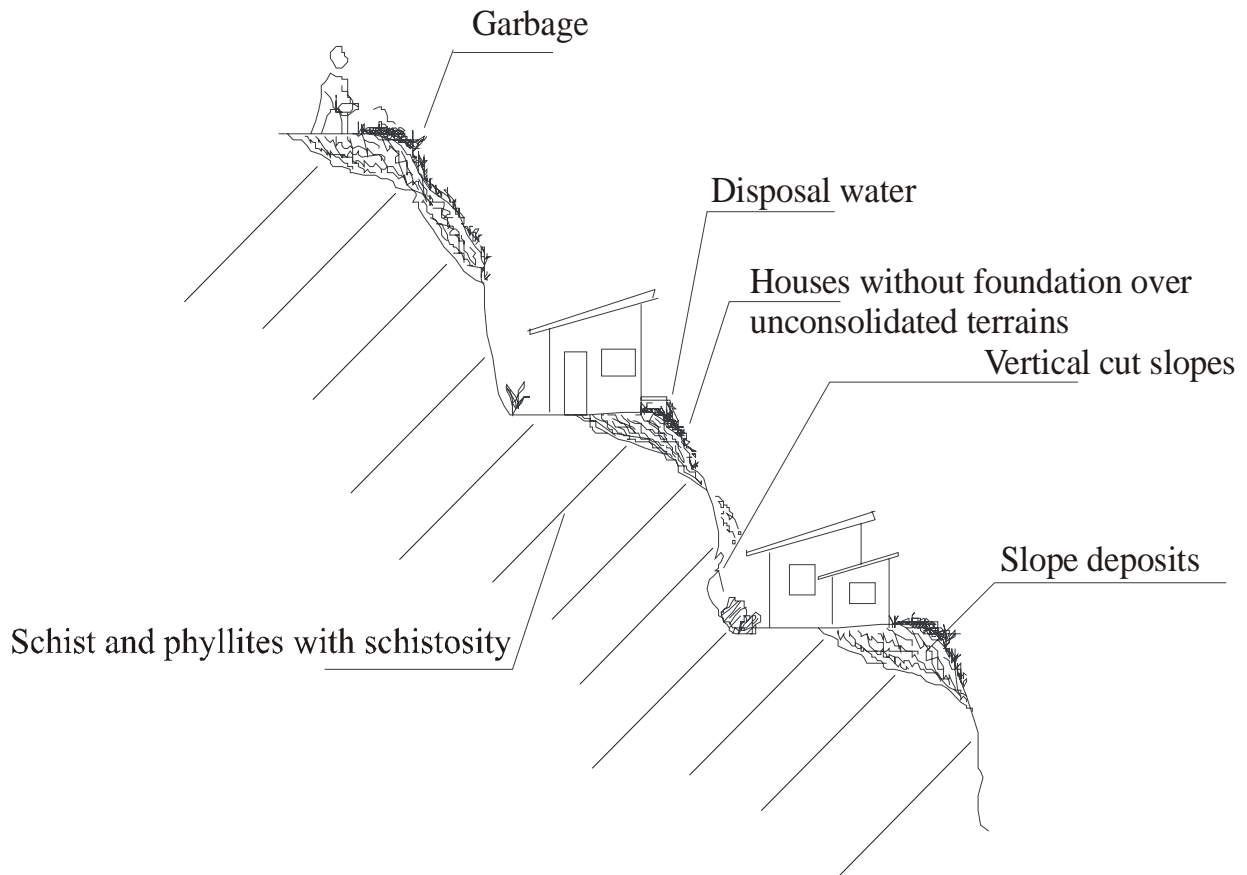
Figure 2.: Typical land-uses at “Taquaril “Slum.

Topography is usually being modified and heaps of garbage and waste material from constructions are daily thrown along the slopes and drainages, creating piles of waste deposits placed in unstable conditions, as shown in Figure 2.

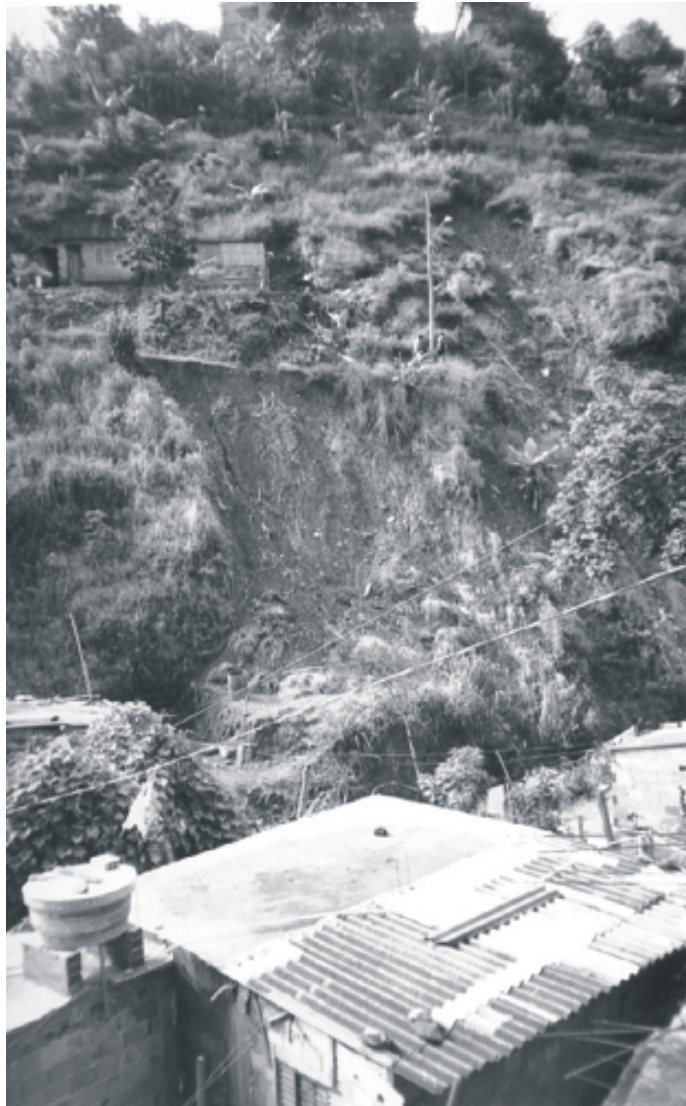
Figure 3. shows a photo of the landslide that occurred in January 2003 and before this failure the slope has showed evident moving signs and small slide scars, which had characterized the imminent risk of failure.

Figure 3.: Taquaril Slope after the landslide occurred on January/2003.

Specific engineering techniques and prevention plans must be employed in the risk areas to mitigate landslides hazards. At Taquaril Slope is recommended the removal of all families that are living there.

Also, the remediation techniques must consider a drainage system for the rock mass. More studies are needed for the talus deposits. The complete removal of the talus material may be considered as an engineer sound solution to stop debris flows; or, at least they must be covered with iron meshes depth anchored in a not weathered rock mass. Finally, erosion control should be reinforced to keep the A and B-horizons in place.

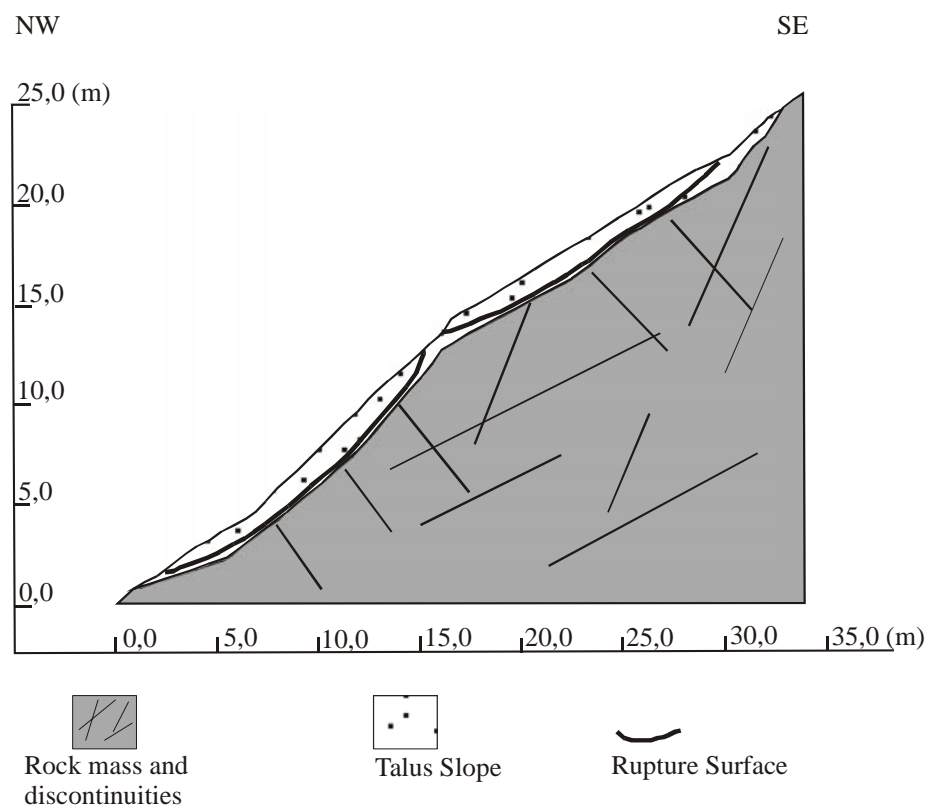
A representative 25 m slope in this area was closely investigated and it is shown in Figure 4. “Taquaril” slope has an inclination of 50° at the first 15m of height (from the bottom of the slope) and turning to 36° near the top of the slope.

Also, during the monitoring period two rotational landslides had occurred in the site. The first one is located at the slope upper face and the second one, at the slope bottom face, as shown in Figure 4. Both failures have occurred at talus deposit.

The values given by back analysis are shown in Table 1. The back analysis results have shown that pore pressure values of 10-11 kPa might been acting in talus deposit during rainy seasons. These values are considered too high. However, it is important to point out that failures had occurred simultaneously to heavy precipitations; the one that had occurred in January 16th, when precipitation rates were exceptional too high, varying from 217mm (one day) to 282mm (accumulated for 4 days), as shown in Table 2. Apparently, pore pressures seem to act mainly along the contact surface between the talus and the rock mass, and landslides are shallow due to the short depth of talus deposit (1.5m). Lower than 10 kPa pore pressure values may induce shallower landslides scars and creep.

Figure 4.: Typical Taquaril Slope profile showing the two failure surfaces that have occurred
